Name of Dam: South Rivanna

Location: Albemarle County, State of Virginia

Inventory Number: VA 00302

PHASE I INSPECTION REPORT
NATIONAL DAM SAFETY PROGRAM

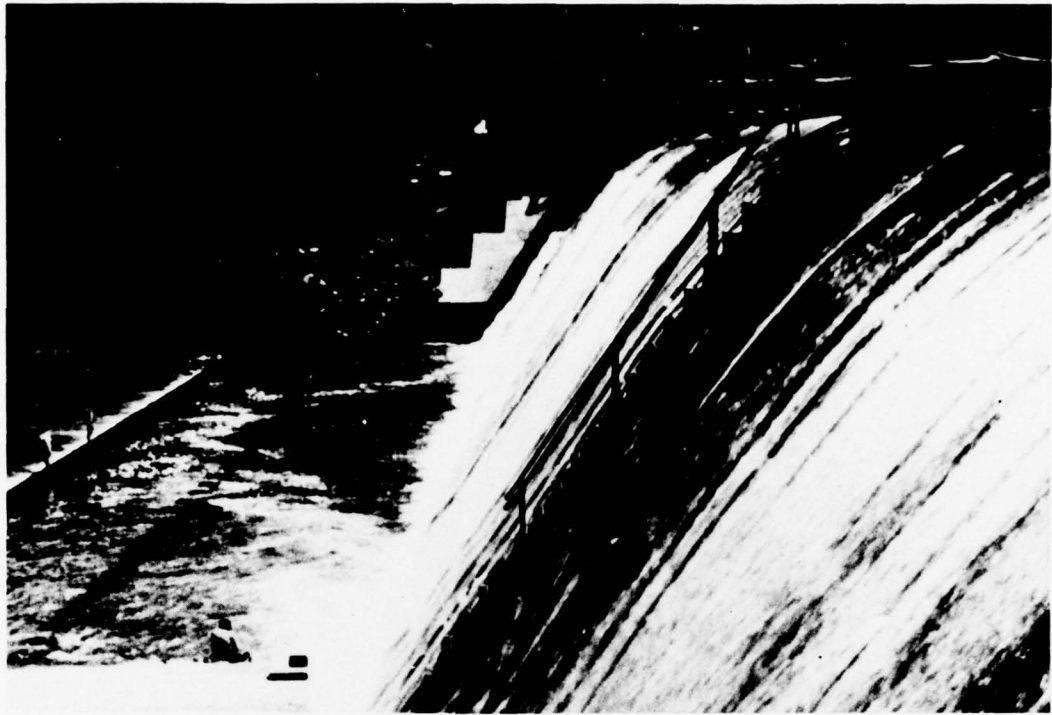
PHOTO 1. View of Dam, Left Chute and Stilling Pond From Abutment Area

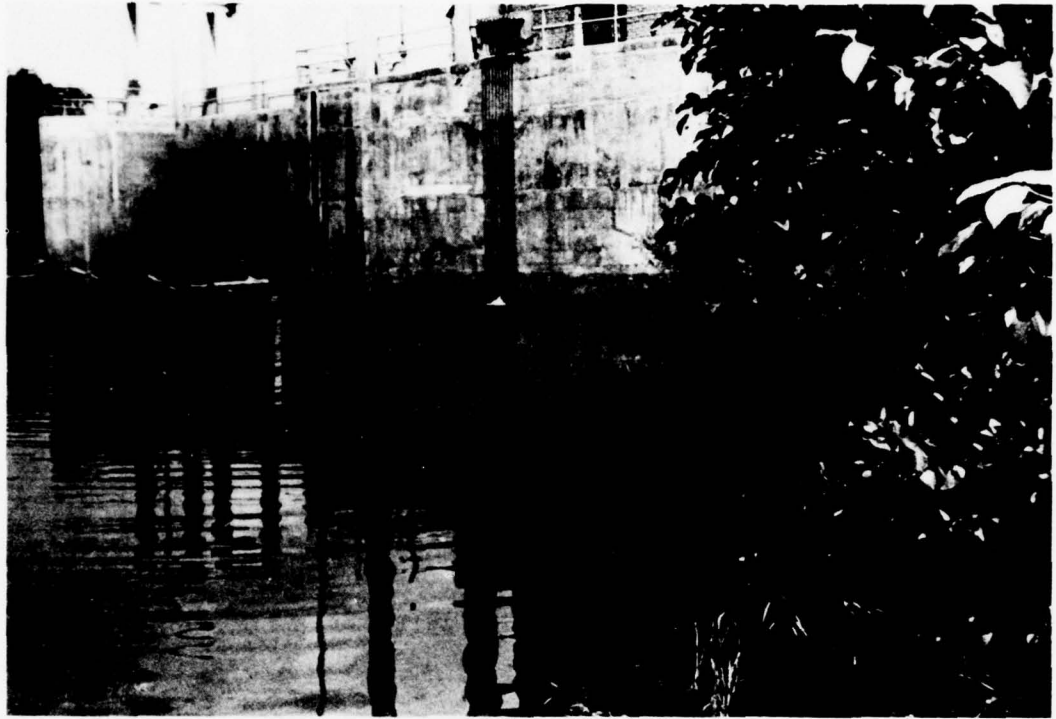
PHOTO 3. View of Upstream Face of Right Non-Overflow Section Directly Above Sluice Gates

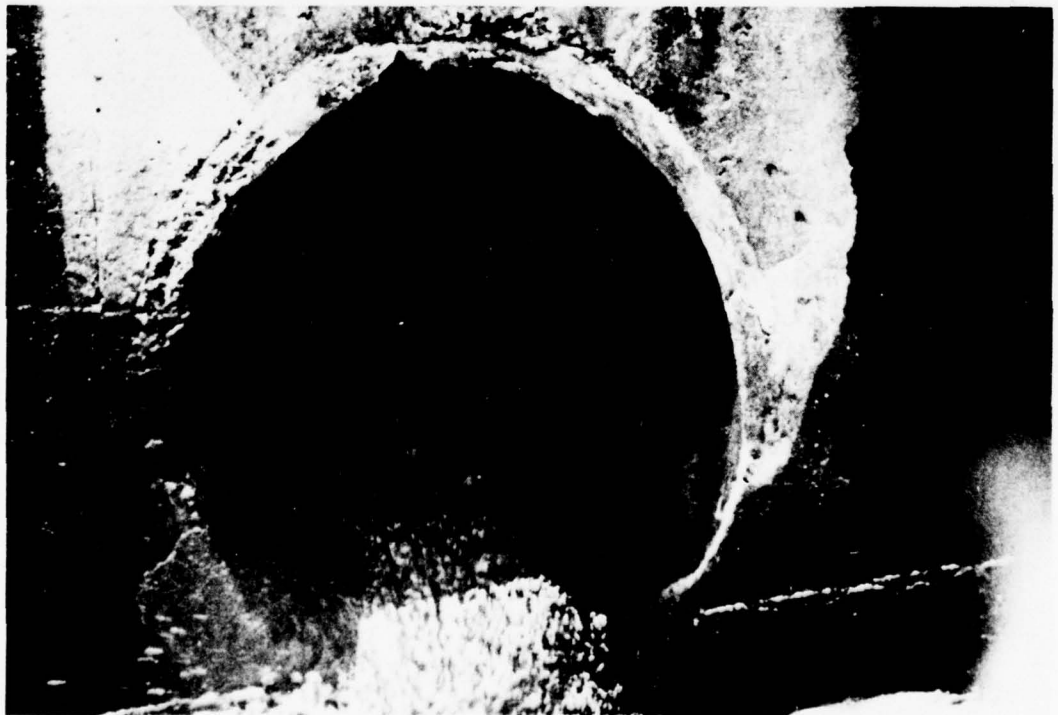
PHOTO 4. View of Outlet of 36 Inch Diameter North Control Conduit

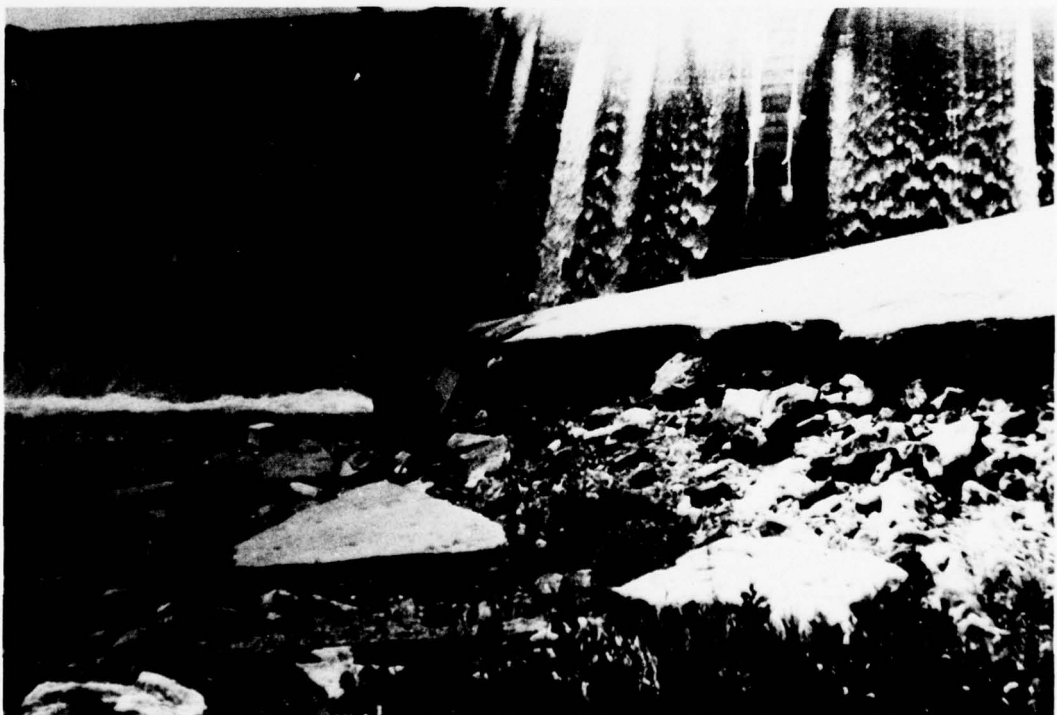
A concrete apron just downstream from the chute in the left abutment area was undermined by the high flows of 1969 and is in poor condition (Photo 6). This apron was eroded and repaired previous to 1969.

3.1.3 Appurtenant Structures: No inadequacies were observed in the concrete of any appurtenant structures. The only deficiency observed was the concrete apron downstream of the chute in the left abutment area.

The concrete apron downstream of the left chute was undermined and eroded twice during high flows.
- 6.2.5 Seismic Stability: The dam is located in Seismic Zone 2; therefore, the dam is considered to have no hazard from earthquake, since static stability conditions are satisfactory and conventional safety margins exist.

PHOTO 6. View of Deteriorated Concrete Apron Downstream of Left Abutment Area

The only item requiring repair is the eroded concrete apron on the left downstream side of the dam.

3.2.2 Appurtenant Structures: The concrete apron downstream of the chute should be repaired to prevent bank erosion during periods of high flow.
